FIELD INVESTIGATIONS OF UNCONTROLLED HAZARDOUS WASTE SITES

Pigeon Point Landfill
New Castle, Delaware

TDD No. F3-8101-17
EPA No. DE - 27

AN ON-SITE INSPECTION
OF
PIGEON POINT LANDFILL
TDD # F3-8101-17
EPA # DE-27

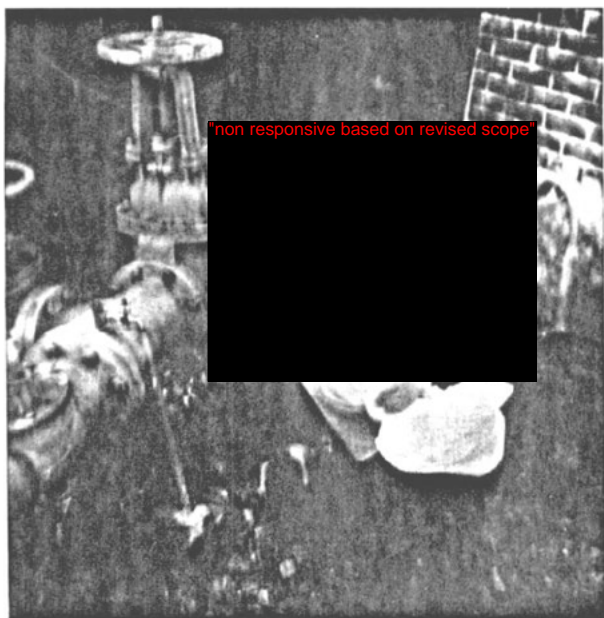
#1 1022 2/5/81 PIGEON POINT Landfill
F3-8101-17
ARTESIAN Water Co. SL#2
Castle Hills #3

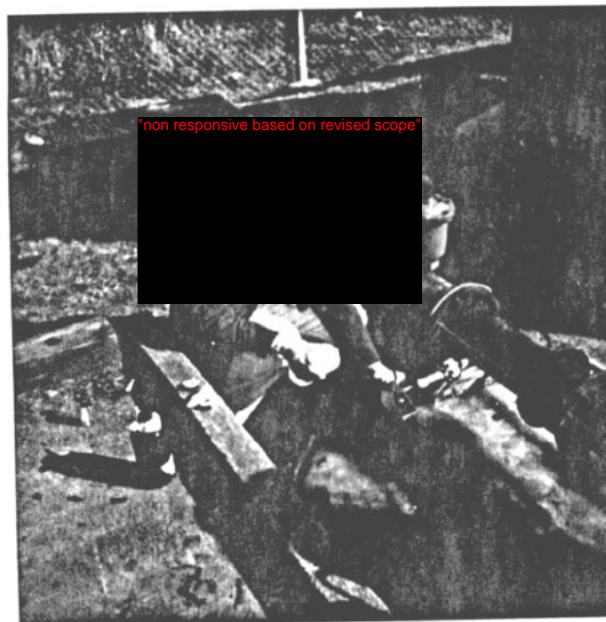
#2 1120 2/5/81 Pigeon Point LF
F3-8101-17
Atlas Point Plant well #9
ICI Americas SL#2

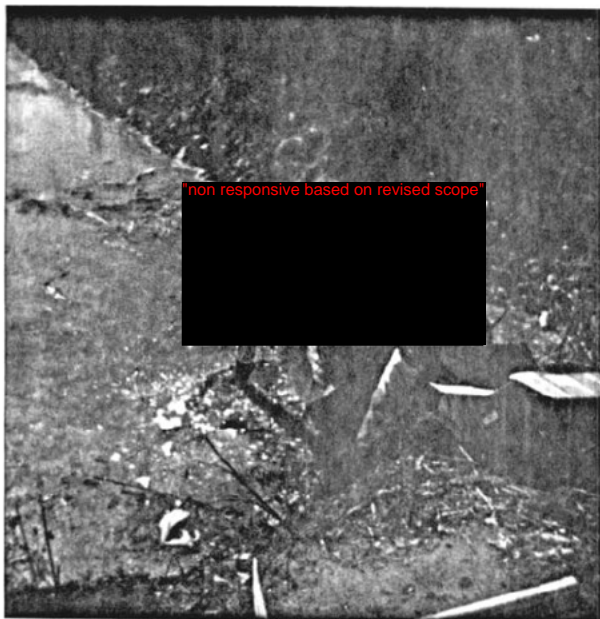
This is a drainage ditch which runs outside of the dredge spoil dike which forms the north perimeter of the landfill proper. Fields, used for depositing municipal sludge, are located just north of this swale. The swale also drains several small ponds and ditches to the west. This ditch is tidal influenced and samples were obtained when the tide was approximately three hours down from a high tide time for Wilmington, Delaware. Surface ice had to be broken through.

1237 2/5/81 PIGEON POINT LA.
#3 F3-8101-17
Northwest Drainage Ditch
SL # 4

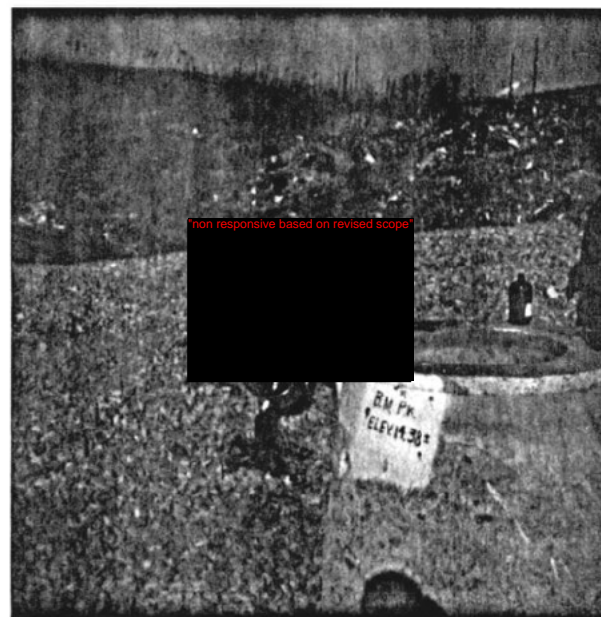
1335 2/5/81 PIGEON POINT LA.
#4 F3-8101-17
outfall, perimeter leachate
collection system SL # 8

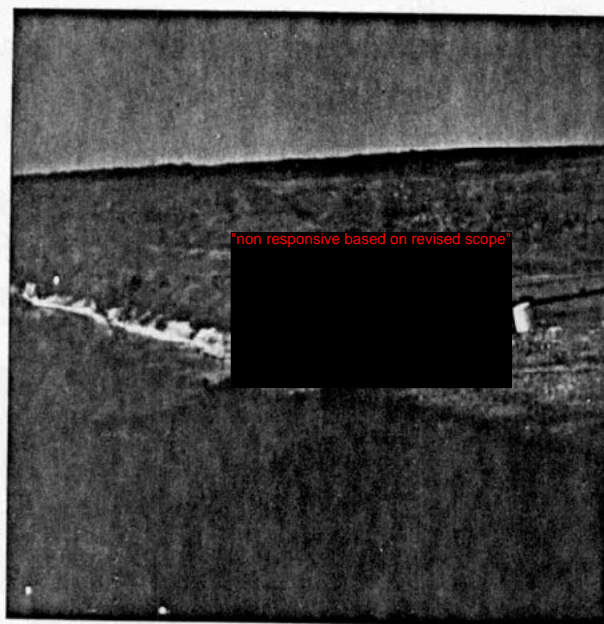
Along the south perimeter of the landfill is a ditch which collects shallow leachate, seepage from the toe, and run-off. This effluent is collected in a small pond and pumped up into a sewer which leads to a treatment plant. The collection pond has a small weir, during periods of extremely high precipitation, run-off flows over the weir directly into the Delaware River, by passing the pump up to the treatment plant. This is a temporary system. The north and east perimeters of the landfill have an underdrain leachate collection system, collected leachate is pumped to a sewage treatment plant. A similar system is planned for the south perimeter but its installation is delayed until the construction of the planned steam generation plant.

Seepage from the south side fo the landfill and overland run-off are collected in this pond. The sample was obtained from an enclosed wet well, from which the effluent is pumped up to the outfall of the north and east perimeter underdrain system. The sump pump had been running for several hours. An oil sheen was observed on the water when it was poured into the sample containers.

#5 1402 2/5/81 PIGEON POINT Lf.
F3-8101-17
south kachate collection swale
SL#7

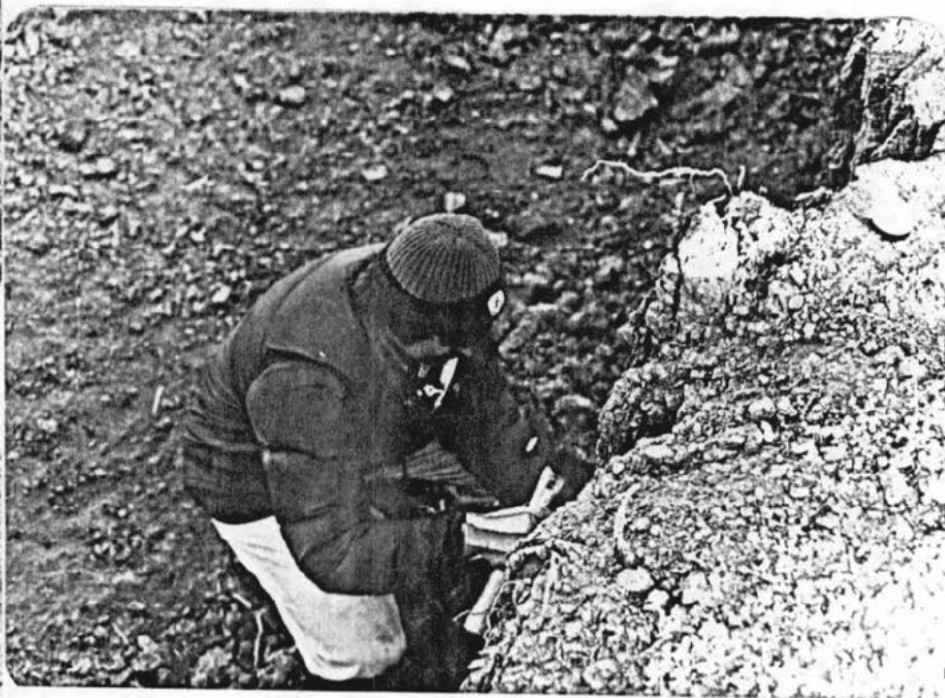
S-6

Sampling Dredge Spoils
SL # 9A
